Docket No. 217 – Development and Management Plan Inspection

Date: May 25, 2005

Location: 345kV XLPE Component

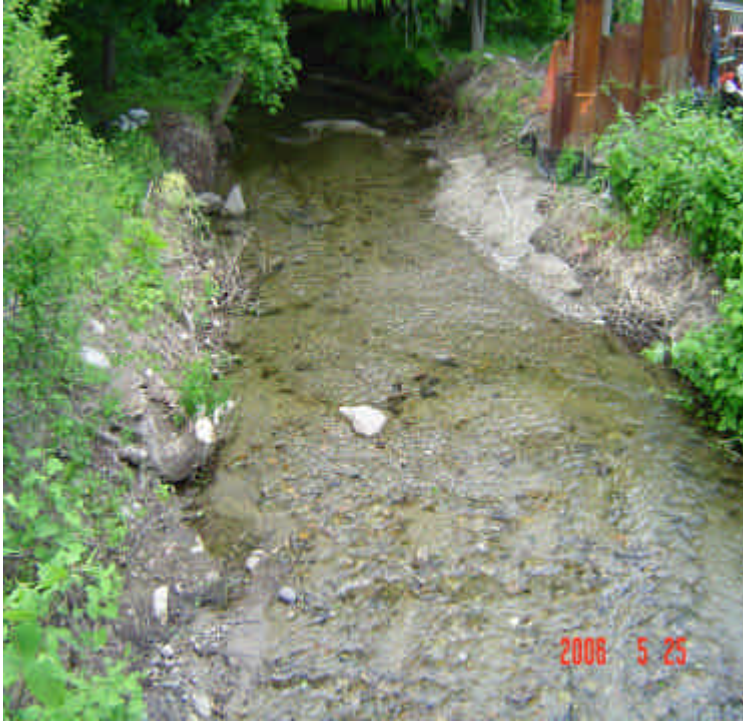
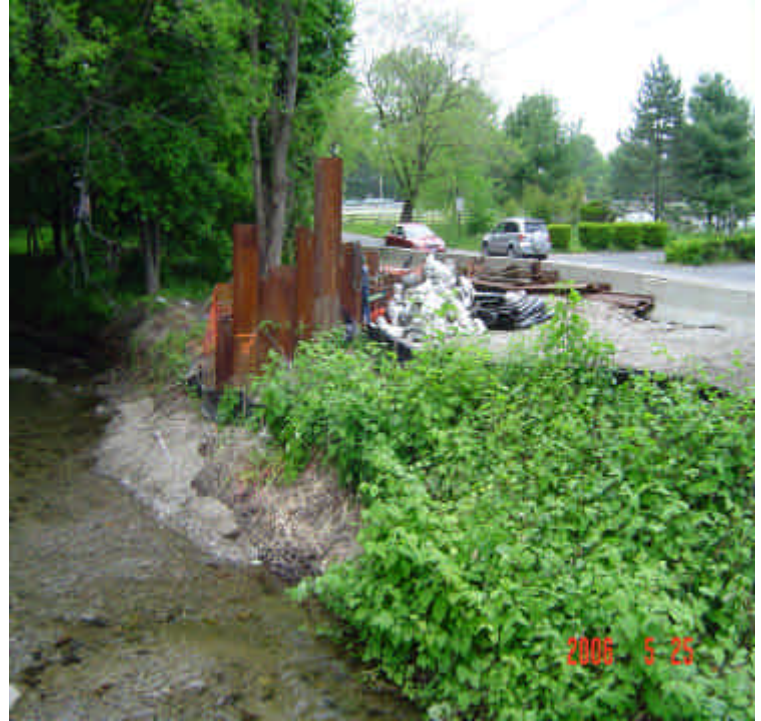
Areas of Inspection	Observation	Recommended Action	Corrective Action
Jack and Bore	-The plastic liner and sandbag diversions were removed from the stream. Work is on hold for the time. 5/25/06	-The stream was still running clear at the time with a natural bed. New solutions are being investigated. 5/25/06	-N/A at the time
Whittlesey Dr and Judd Ave	- Previously disturbed areas adjacent to the trench were all well restored. 5/25/06	- Continue to monitor. None at this time. 5/25/06	- Restoration was complete
Rt. 58	- One catch basin located north of Hoyts Hill was noted without controls but the remainder were placed with filter fabric. 5/25/06	- Protect the remaining CB due to sawcutting in the area. 5/25/06	- Most CBs are being covered. One needed controls
Hoyts Hill	-Equipment tracking was noted in the wetland beyond the stone access where mats had previously been. 4/19-5/25/06	- Mats may have been removed prematurely. The wetland surface should be restored when work is complete here. 4/19-5/25/06	-Needs attention when work is complete

Inland Wetland and Watercourse encroachment and mitigation	-East Swamp Brook crosses under Plumtrees Rd. Sandbags and liners were removed from the stream. 5/25/06 -Problems with excess water continue in the trench and further methods are being evaluated. 5/4-5/25/06.	- The stream continues to run clear with the natural substrate restored. 5/25/06 - Sheet piling in the stream may be necessary and appropriate permits will be obtained. Options are still being evaluated 5/4-5/25/06	-Sandbags and liners were removed - N/A at this time.
State species of concern, threatened and endangered species	-The D&M plan and clearance letter states that state-listed species are not located in this work area. -The wood turtle was noted at Plumtree Substation during the inspection. 5/25/06	- N/A -345kV XLPE crews should also be performing daily walkthroughs before moving equipment while working in the vault. Be vigilant when moving equipment. 4/26-5/25/06	-N/A - Crews were informed

**345kV XLPE: Both photos show the stream in the vicinity of the jack & bore. All sandbag diversions and liners were removed from the other as other alternatives are being permitted.
5/25/06**

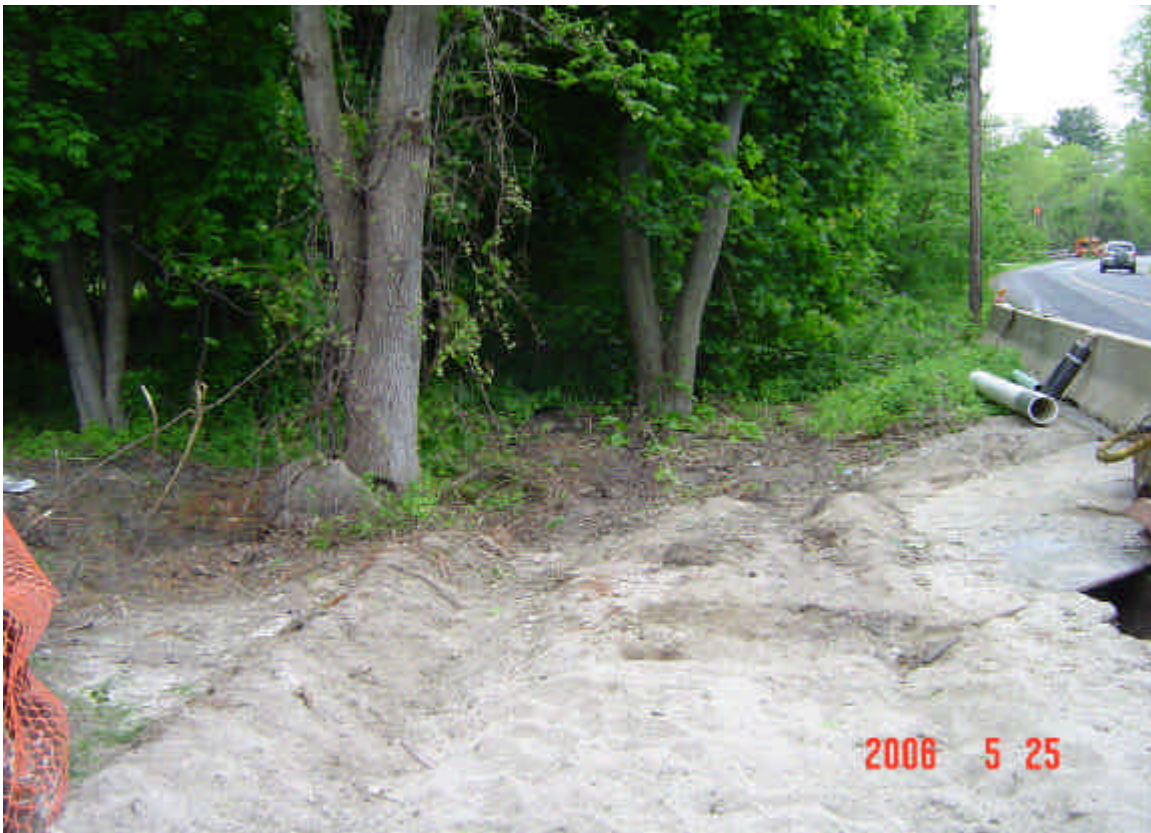
Areas of Inspection	Observation	Recommended Action	Corrective Action
	been removed from the wetland vegetation near the receiving pit. 5/25/06

Photo shows where the dewatering box and additional materials were moved out of the wetland vegetation adjacent to the receiving pit at the J&B. 5/25/06

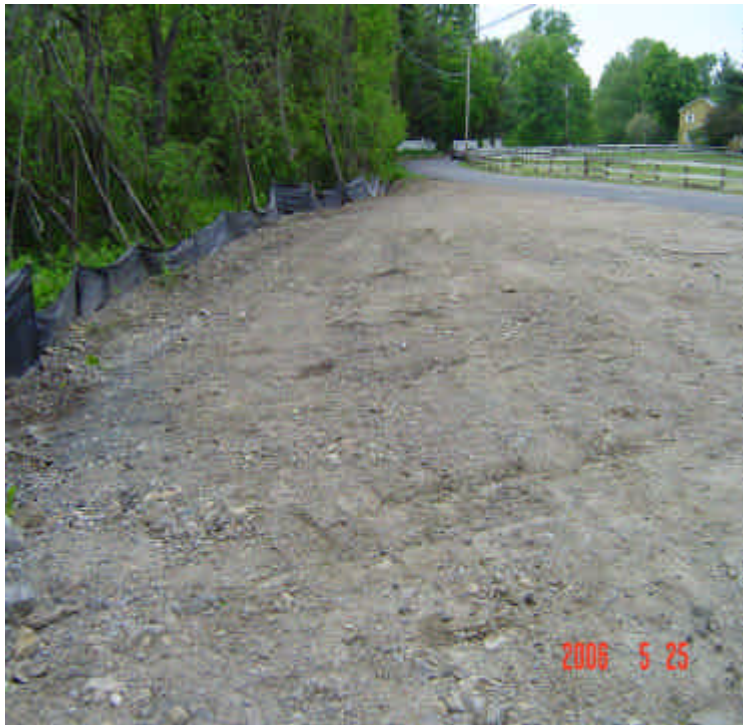
-Work is complete in the pull-off near vault 2a and b and the area should be restored. 5/10-5/25/06	-See EC section for more details. 5/25/06	-Recent rains delayed the restoration attempts
	-Sawcutting was observed along Rt. 58. 5/25/06	- See EC section for more details. Trench work on Rt. 58 will continue soon. 5/25/06	-N/A
	-Vaults were being accessed to pull cable between some locations. 5/25/06 -The trench is complete along the slope at Hoyts Hill with a small area of open trench remaining at the base. 4/6-5/25/06	- None at this time. 5/25/06 - See erosion control section for more details 5/25/06	- N/A - N/A
Erosion and Sediment Controls (includes inspection within 24 hours of a storm event) Walnut Hill Rd.	- Work is complete near vault 2A&B. Silt fence remains in place but the area will need some restoration. 5/10-5/25/06	- Efforts were made to bring in topsoil but recent rains caused delays. 5/17-5/25/06 Keep stone surface to the minimum necessary. Allow natural revegetation where possible. 5/10-5/25/06	-Rains caused a delay in efforts

Photo on the left shows the area of vault 2 which is waiting to be restored. Photo on the right shows where roadside areas along Whittlesey Dr. have been restored, seeded and mulched. 5/25/06

Areas of Inspection	Observation	Recommended Action	Corrective Action
Vegetative clearing limits (including trees to save or danger trees noted)	<p>-All previously disturbed areas along the roadsides were well restored. 5/25/06 (Vault 2 remains)</p> <p>- When restoring vault 2, a stone surface will be necessary over the vault but wetland vegetation is returning near the silt fence. 5/4-5/25/06</p>	<p>-Monitor for vegetation. 5/25/06</p> <p>- Keep the stone area to the minimum necessary and restore vegetation in the remaining area. 5/4-5/25/06</p>	<p>-Restoration had occurred.</p> <p>- Efforts were delayed by rain</p>
Dewatering	-The amount of water continues to overwhelm the dewatering efforts at the jack and bore. Work is on hold. Further actions are being evaluated here. 5/25/06	- The diversions were all removed from the stream and sheet piling cofferdams are being permitted. 5/25/06	-N/A
Blasting	- No blasting is occurring at this work area.	- None at this time.	-N/A

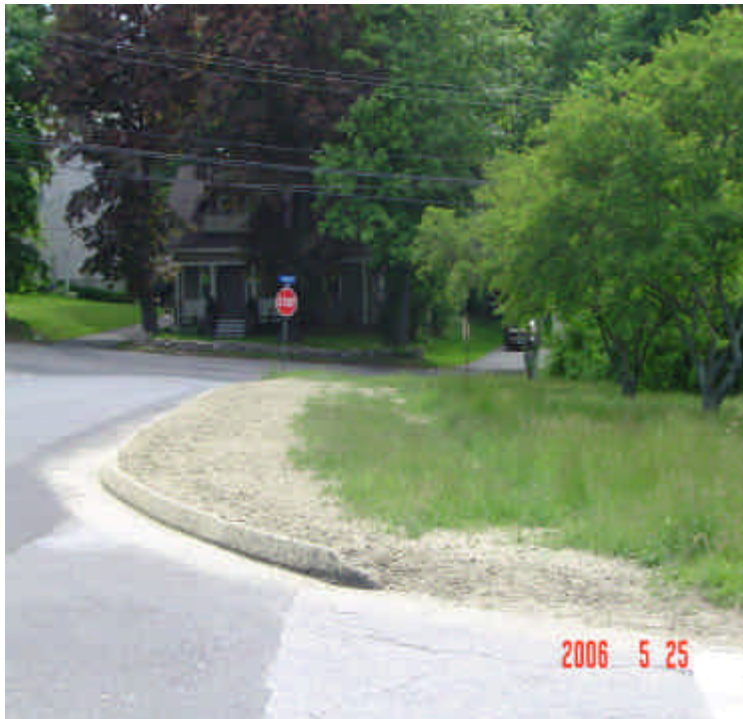
Photo on the left shows the intersection with Judd Ave with roadside areas restored. Photo on the right shows the sawcutting along Rt. 58. Most catch basins were protected with filter fabric. One located just north of Hoyts Hill was left uncovered. 5/25/06
